APOLLO 15
30-DAY FAILURE AND ANOMALY LISTING REPORT

MANNED SPACECRAFT CENTER
HOUSTON, TEXAS
SEPTEMBER 1971

1.0 INTRODUCTION

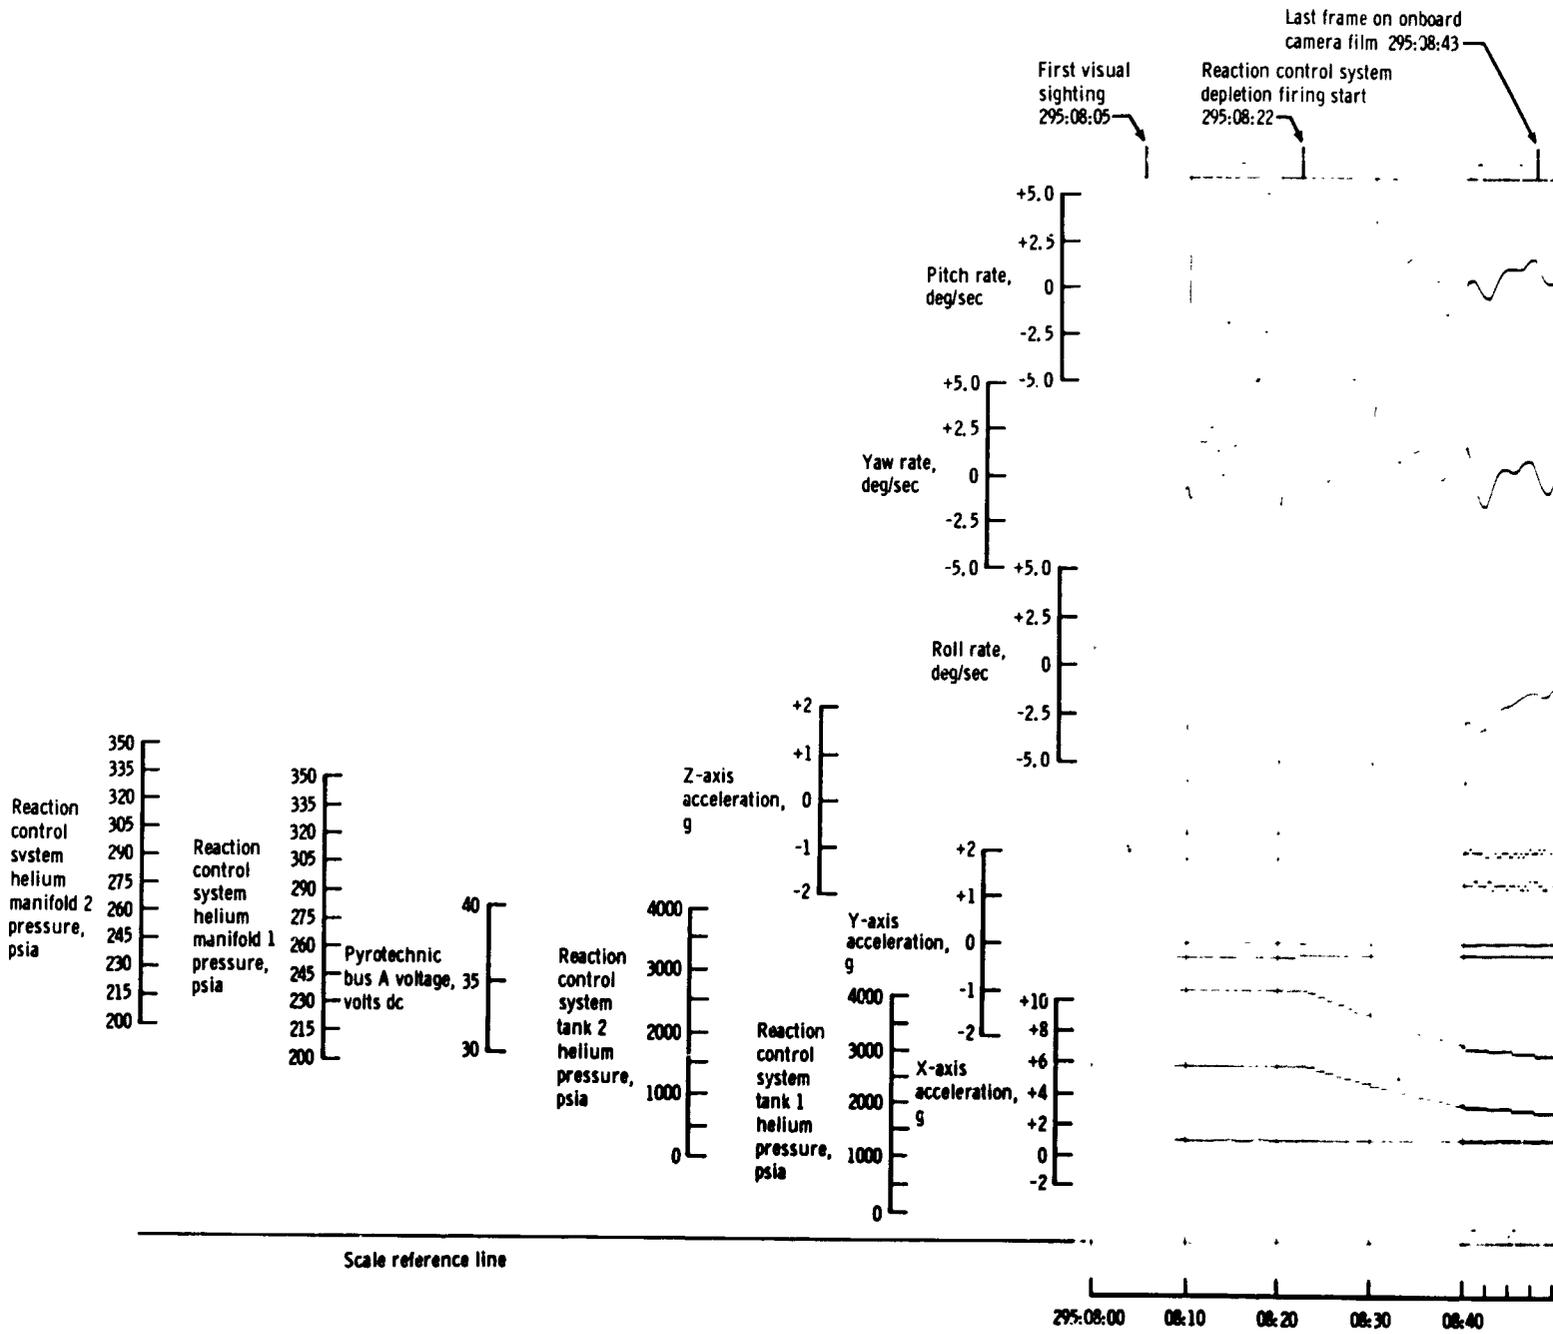
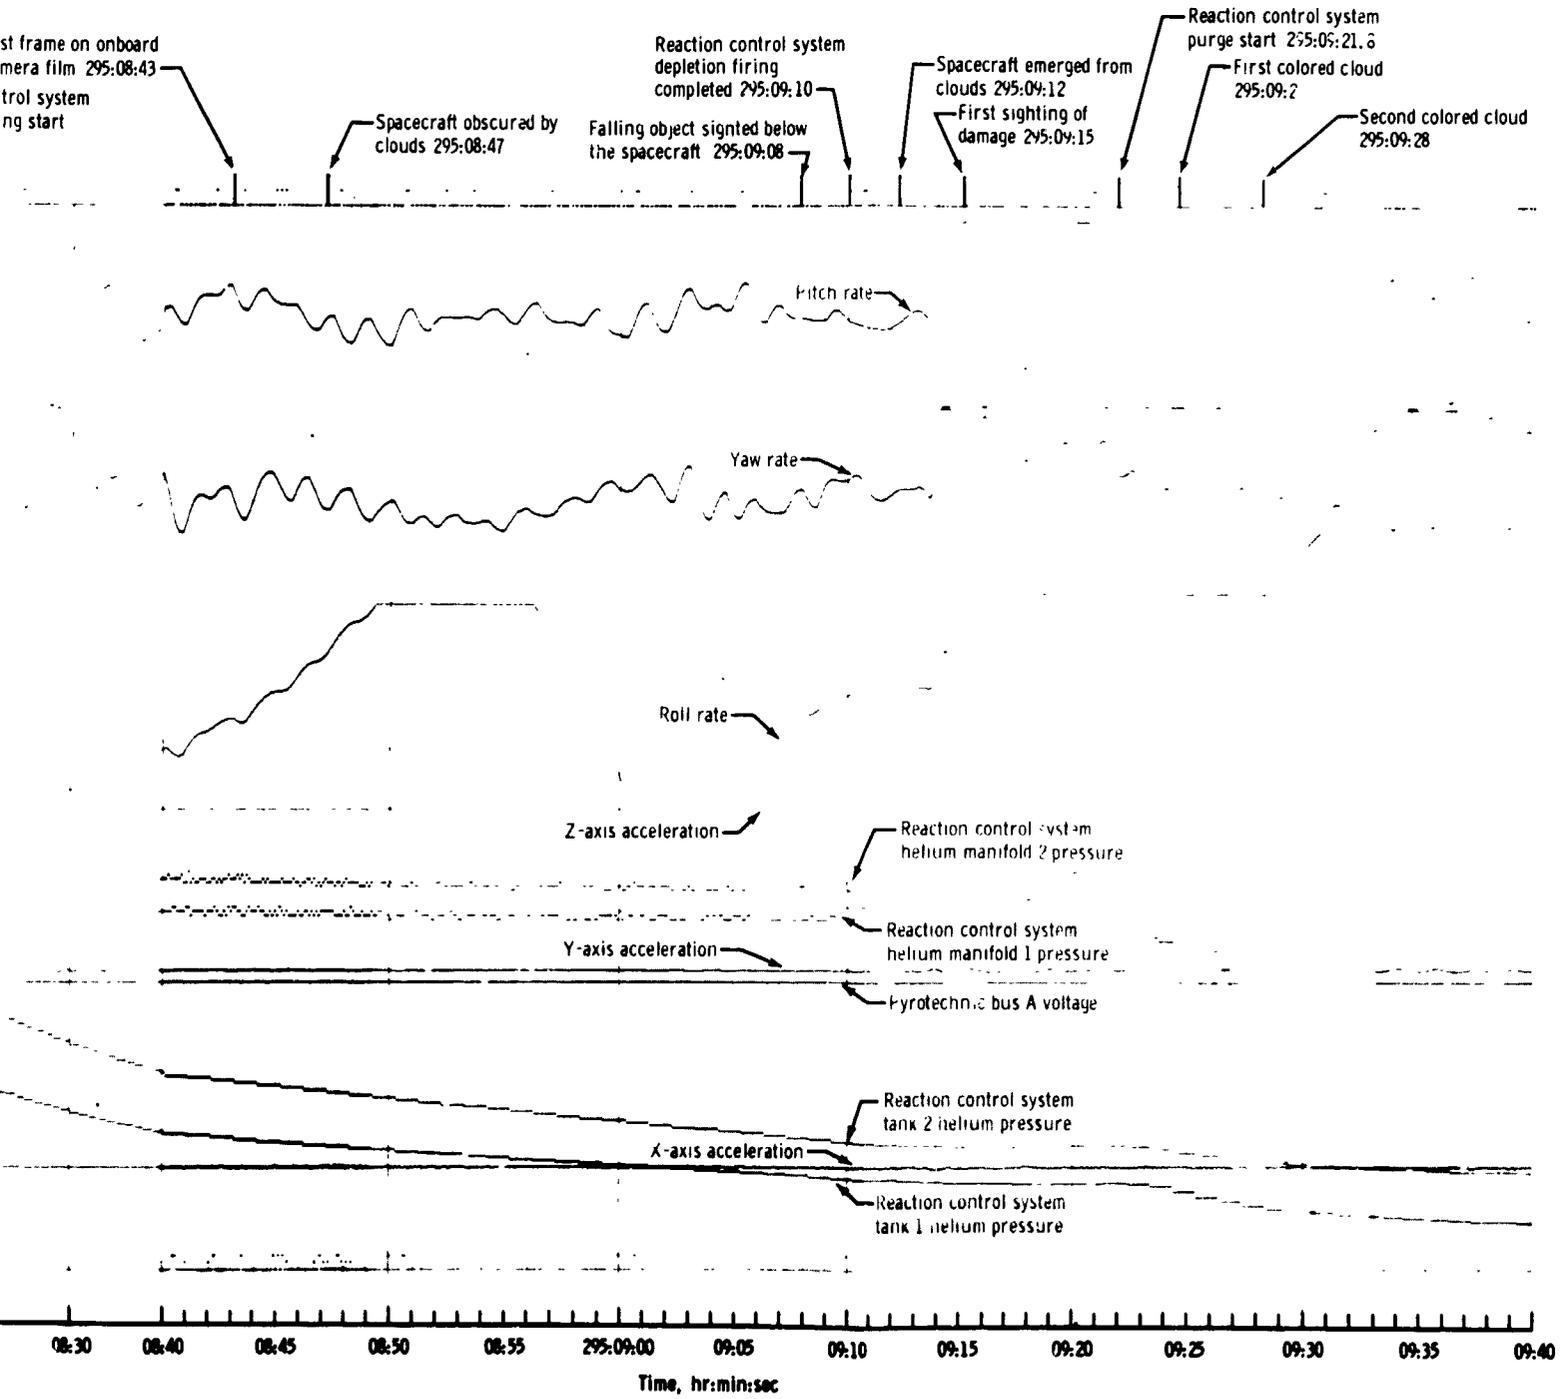
Figure 2-11. - Sequence of events during descent on the main parachutes.

One of the three main parachutes was deflated to approximately one-fifth of its full diameter at about 6000 feet altitude. The command module descended in this configuration to water impact. All three parachutes were disconnected and one good main parachute was recovered. Accelerometer and rate data show that the load was abruptly relieved about 4 seconds after the reaction control system depletion firing, but before the reaction control system purge had been initiated. The parachute that failed was over the minus pitch and roll reaction control engines to satisfy the force vectors indicated by the accelerometers (fig. 2-11). Photographs of the descent indicate that two or three of the parachute risers were missing (fig. 2-12).

- a. Forward heat shield which was in close proximity to the spacecraft flight path.
- b. Command module reaction control system propellant firing which was just completed.
- c. Broken riser suspension line link which was found on the recovered parachute (fig. 2-13).

The command module reaction control system depletion firing was considered a possible candidate because of the known susceptibility of the parachute material (nylon) to damage from the oxidizer, and the fact that the depletion firing was completed 4 seconds prior to the occurrence of the anomaly. Further, the command module position at the time of the anomaly placed the failed parachute in close proximity to the reaction control system minus pitch engines. To destroy the nylon risers with oxidizer, a significant amount of wetting would be required. A malfunctioning reaction control system, such that only oxidizer valves would be open,

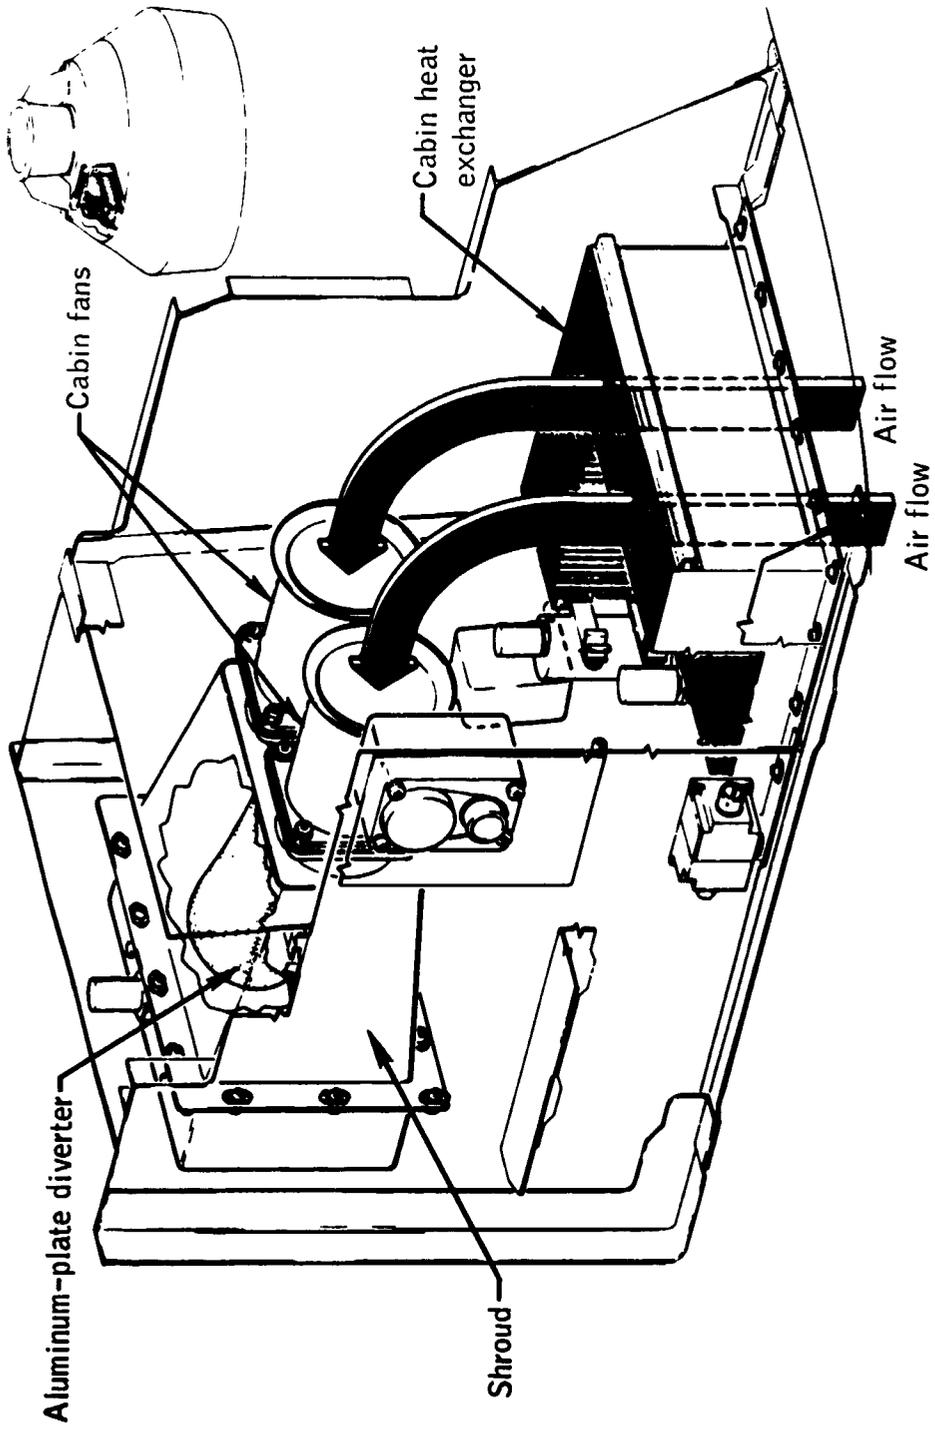
Figure 2-15.- Cabin fan installation.

During portions of the flight when the cabin fans (fig. 2-15) were activated, noises were heard which sounded like an object striking the blades, and lodging of the object within the fan housing even stopped the fan. Cycling the fans several times allowed the fan to run again.

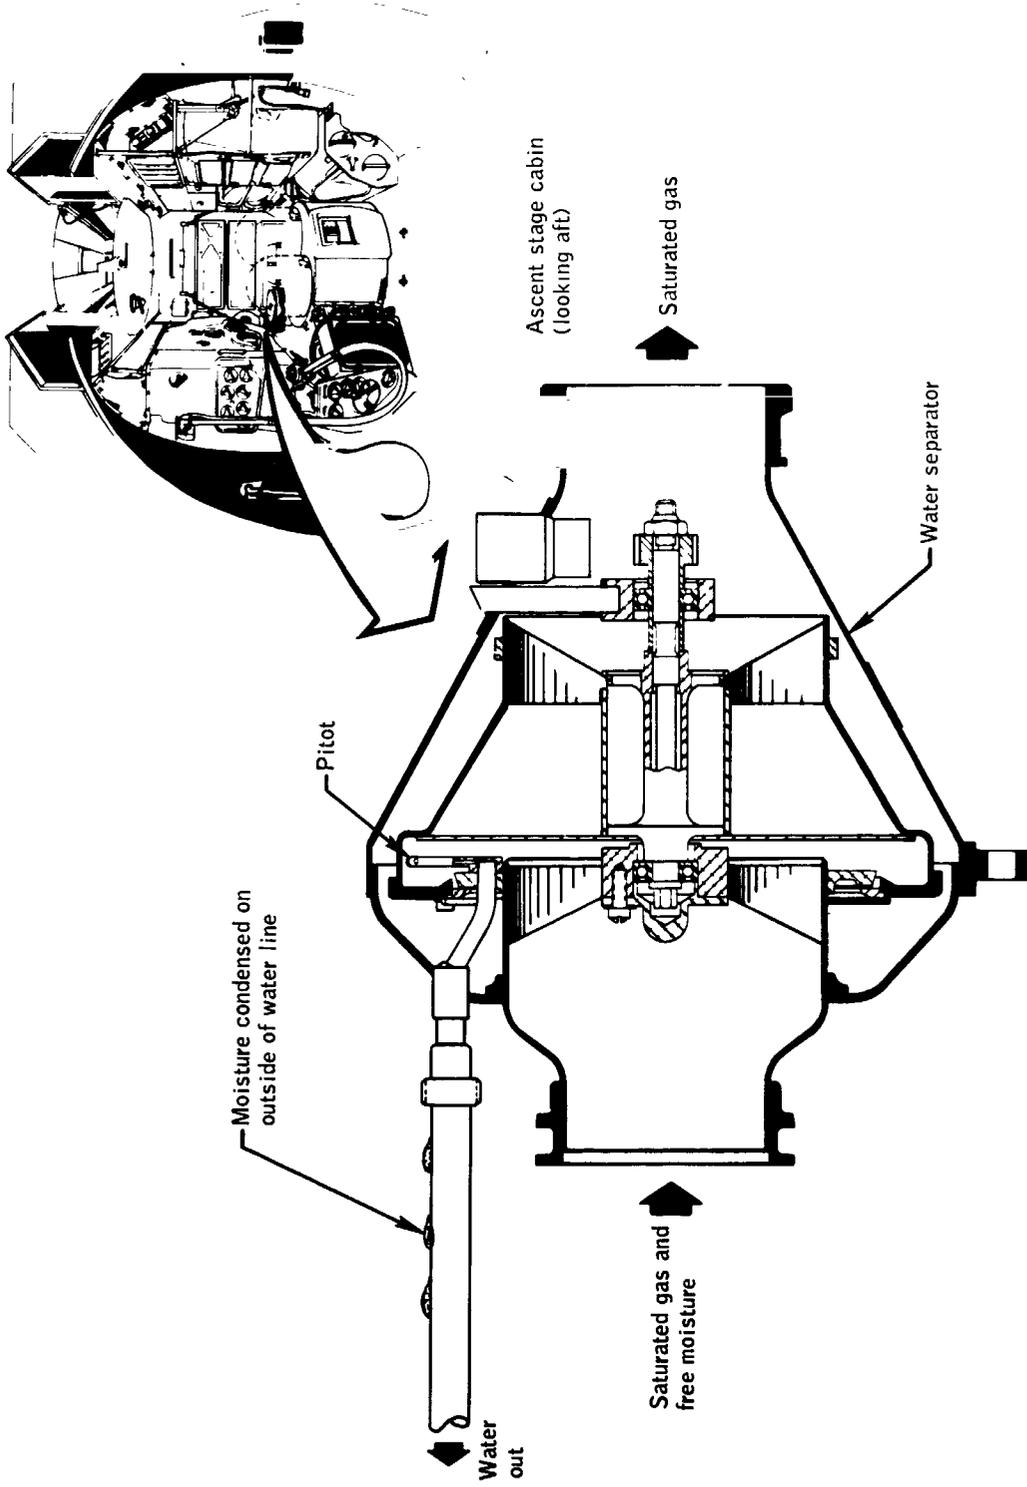
Figure 3-3.- Cross section of water separator.

Cabin atmosphere is cooled and passed through one of the water separators (fig. 3-3) where condensed water is separated by centrifugal force and picked up by a pitot tube. The water is then piped from the pitot tube, through a check valve, to the water management system where it is used in the sublimator.

Analysis shows that as little as a 0.01-inch film of water on the outside of the line would freeze the line at cabin depressurization. Freezing within the line would cause the separator to slow down and stall because of excessive water. Since separator 2 had not been in use, there was no water in its outlet line to freeze, and therefore, it operated successfully at startup. In any event, analysis and tests have shown that freezing of the line will not damage any spacecraft hardware. In addition, no cabin depressurization is planned for any future mission where the crew would be using the spacecraft water separators and where cabin humidity would be high. If such a depressurization is performed, the water separator line would probably again freeze. If this were to occur, however, the other separator would be used. Therefore, no corrective action is required.

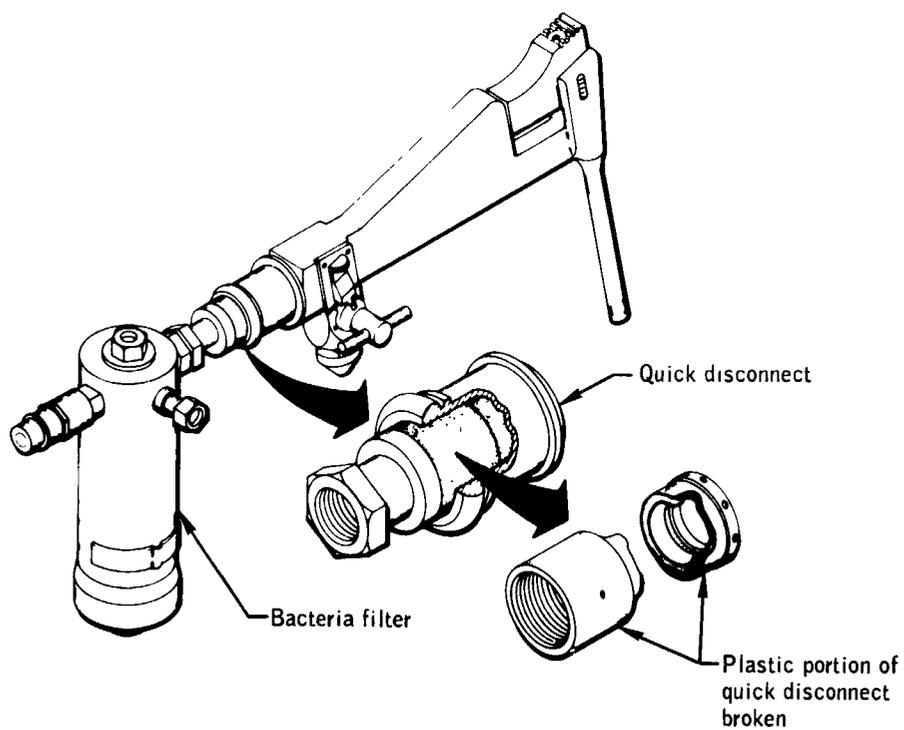
Figure 3-4.- Water gun/bacteria filter.

A water leak developed in the lunar module cabin shortly after crew ingress following the first extravehicular activity. The leakage occurred at the quick disconnect between the bacteria filter and the water gun (fig. 3-4). The leakage was stopped by removing the filter. The plastic (Delrin) portion of the disconnect had broken in half, thus causing the leakage.

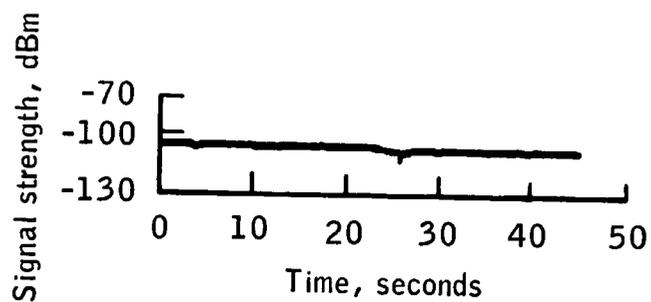
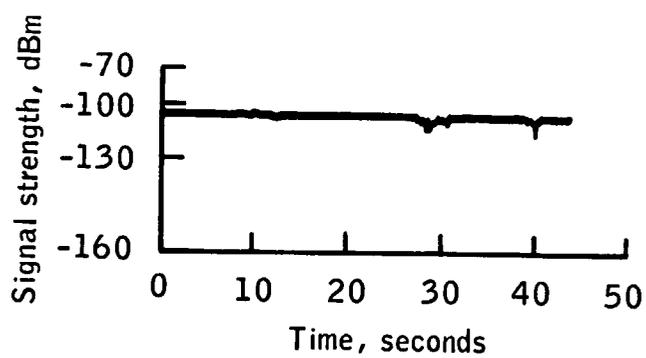
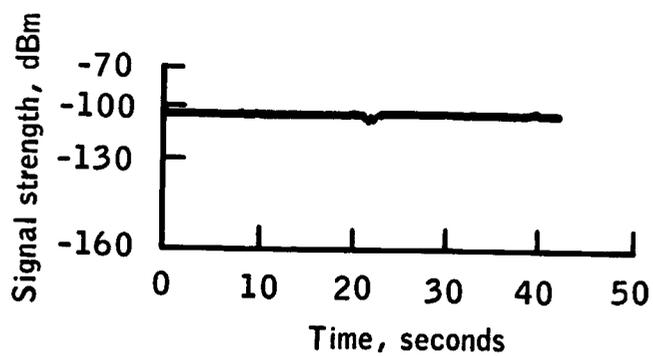
Figure 3-5.- Damped antenna oscillations at random times.

Small oscillations occurred at random while the steerable antenna was in the auto-track mode of operation. With the following exceptions, the oscillations were small and damped out without losing auto-track capability (fig. 3-5). At the following three times the oscillations became divergent as shown in figure 3-6.

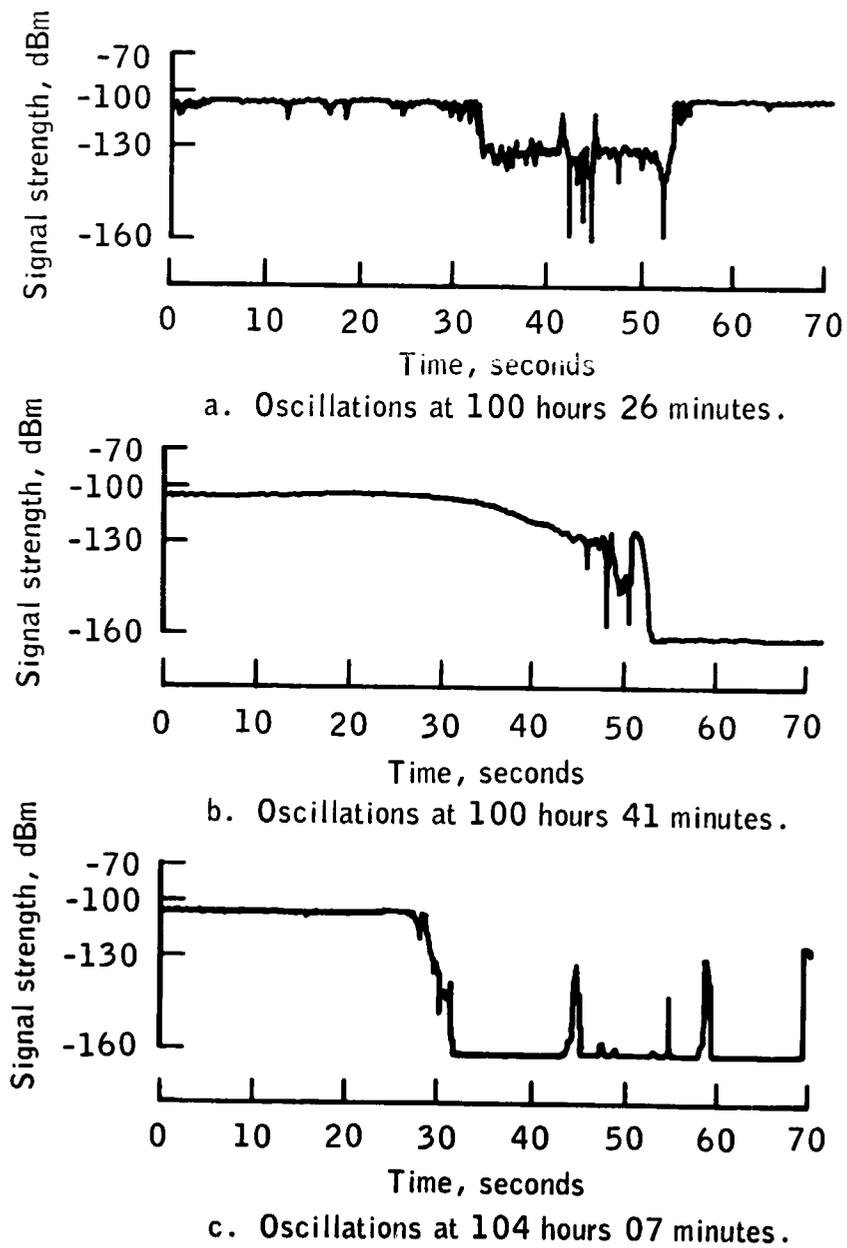
Figure 3-6.- Received signal strength plots associated with divergent antenna oscillations.

a. 100:26 (revolution 12): This divergence occurred prior to separation and was not caused by vehicle blockage or reflections from the command and service module structure.

b. 100:41 (revolution 12): The lunar module maneuver performed approximately 2 minutes after separation caused the antenna to track into vehicle blockage which resulted in the antenna oscillation and loss of lock.

c. 104:07 (revolution 14): Earth look angles for this time period indicate that the antenna was clear of any vehicle blockage. However, since this divergence occurred just after acquisition of signal, the lunar module was still close to the lunar horizon, and the problem may have been caused by multipath reflections from the lunar surface.

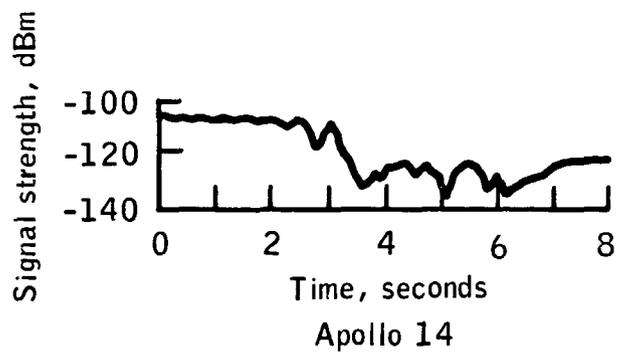
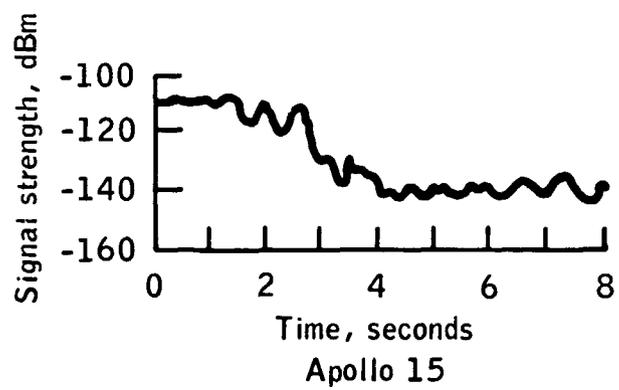
Figure 3-7.- Apollo 14 and 15 antenna oscillation characteristics.

Both the small oscillations which damped out and those which became divergent indicated characteristics identical to the conditions experienced on Apollo 14 (fig. 3-7). One of the prime candidates considered after Apollo 14 as a possible cause was incidental amplitude modulation on the uplink signal. A monitor capable of detecting very small amounts of incidental amplitude modulation was installed at the Madrid Manned Space Flight Network site for Apollo 14. The data from this monitor have indicated that no amplitude modulation at the frequencies critical to antenna stability existed on the uplink during the problem times. Consequently, incidental amplitude modulation has been eliminated as a possible cause of the antenna oscillations, and the problem must be in the spacecraft.

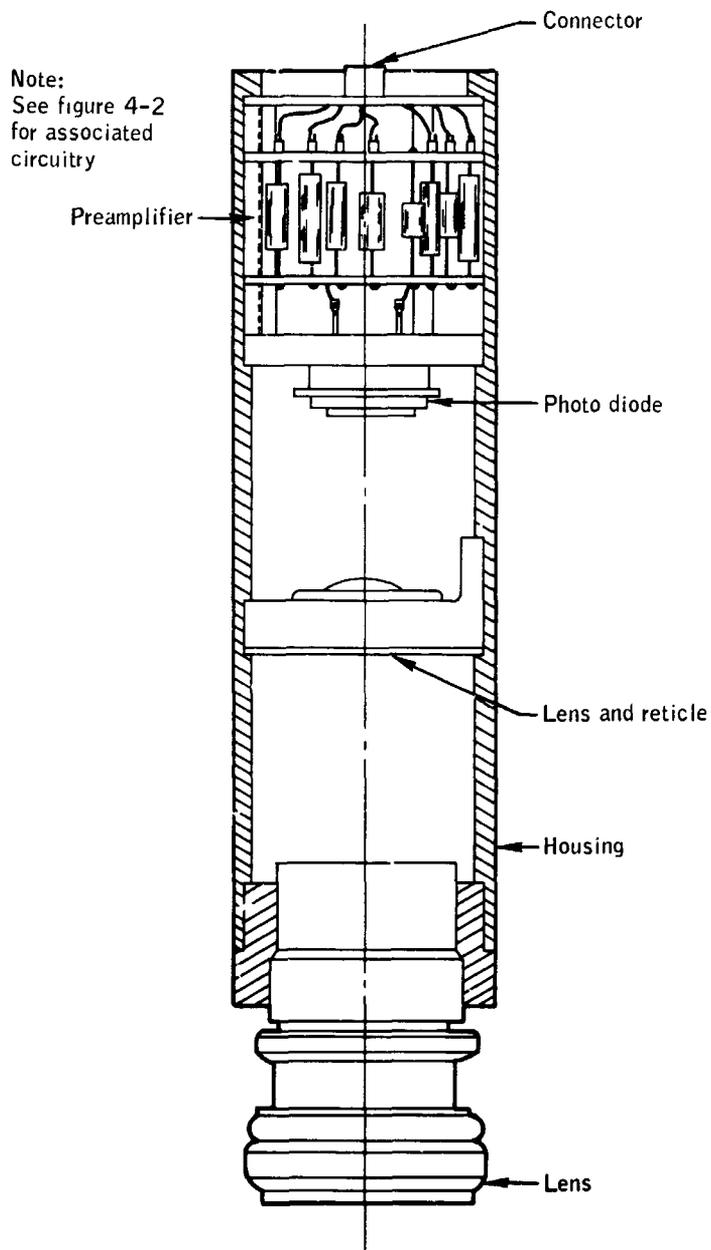
Figure 4-1.- Velocity/altitude sensor assembly.

Telemetry received from the first panoramic camera pass on revolution 4 indicated the velocity/altitude sensor (fig. 4-1) was not operating correctly.

Telemetry indicates that the velocity/altitude sensor tended to operate properly for brief periods of time, but would drift off-scale high (saturate), and then reset to the nominal value corresponding to a 60-nautical-mile altitude. Evaluation of the velocity/altitude telemetry data indicates that approximately 75 percent of the photography should be of excellent quality, with the remainder degraded to various degrees. Preliminary viewing of the developed film did not disclose gross degradation, but an extensive review using a microscope will be required for a valid quantitative assessment of overall picture quality.

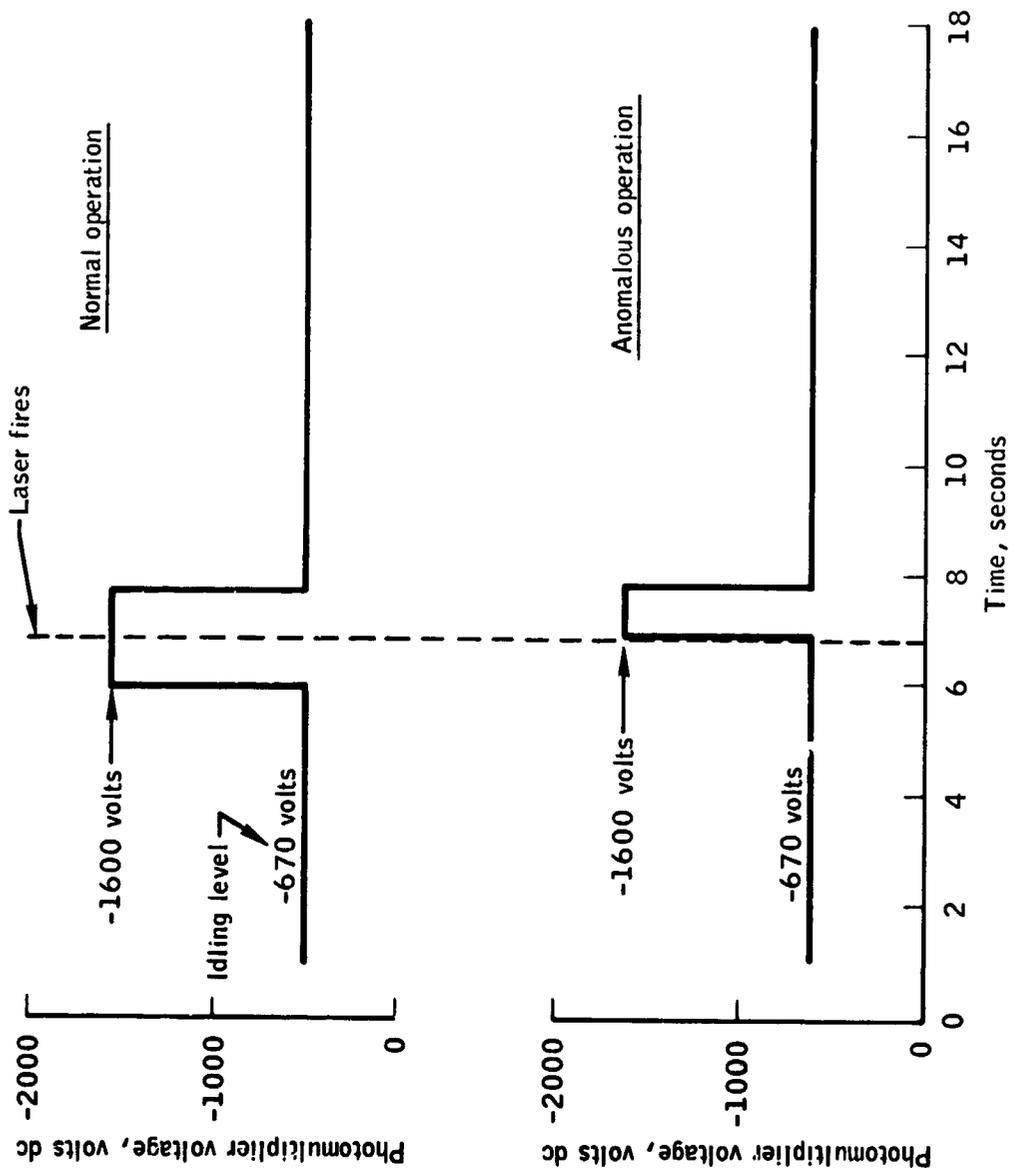
Figure 4-3.- Comparison of photomultiplier power supply voltages .

b. Starting on revolution 38, the photomultiplier tube high-voltage power supply was held in the idling (minimum-voltage level) mode until after the laser was fired, thereby causing the receiver to miss the return pulse from the lunar surface (fig. 4-3). No altitude data were obtained after this anomaly occurred.

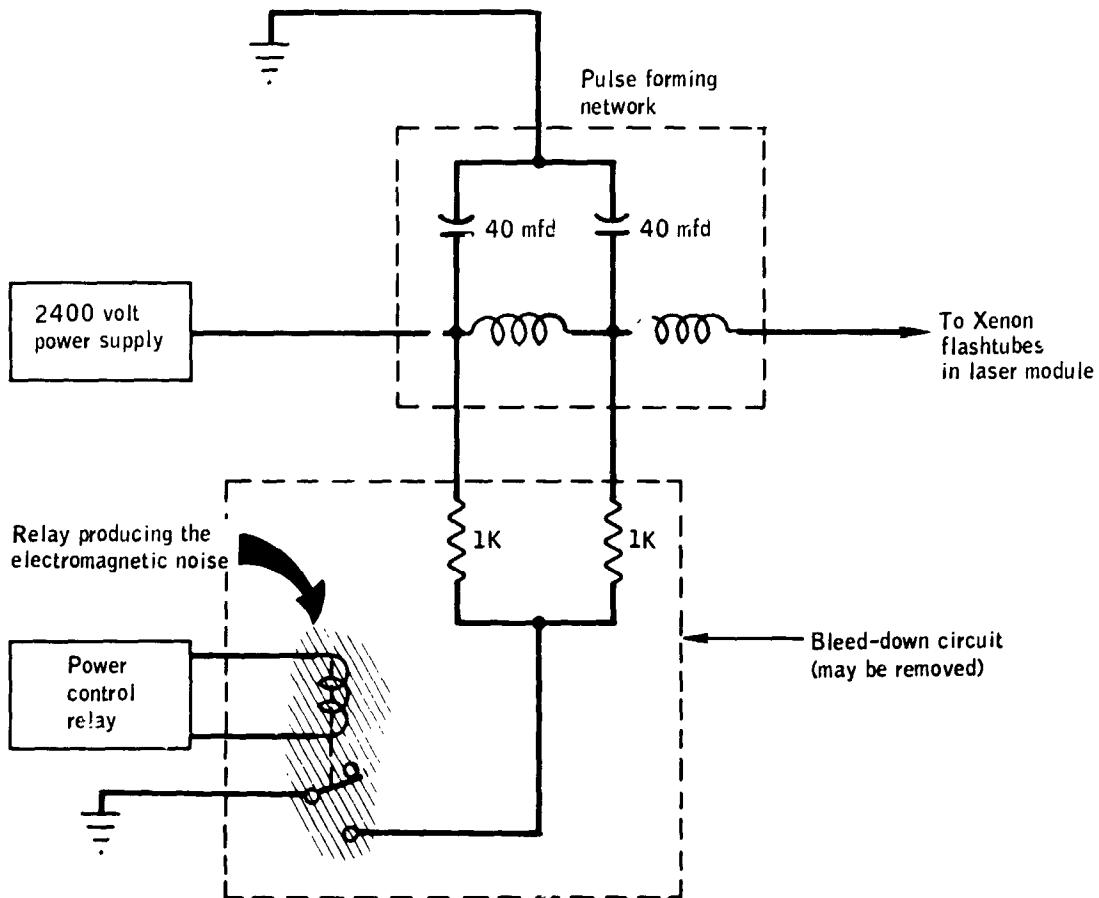
Figure 4-4.- Pulse forming network bleed-down circuit.

A relay which had been removed from a flight unit because it had exhibited an audible "buzz" was installed in the prototype altimeter and the photomultiplier tube power supply anomaly was duplicated. The relay serves no function in flight, but is used as a safety precaution for personnel working on the altimeter (fig. 4-4). The relay contacts close when the altimeter is turned off, thus discharging the high voltage stored on the pulse-forming network capacitors.

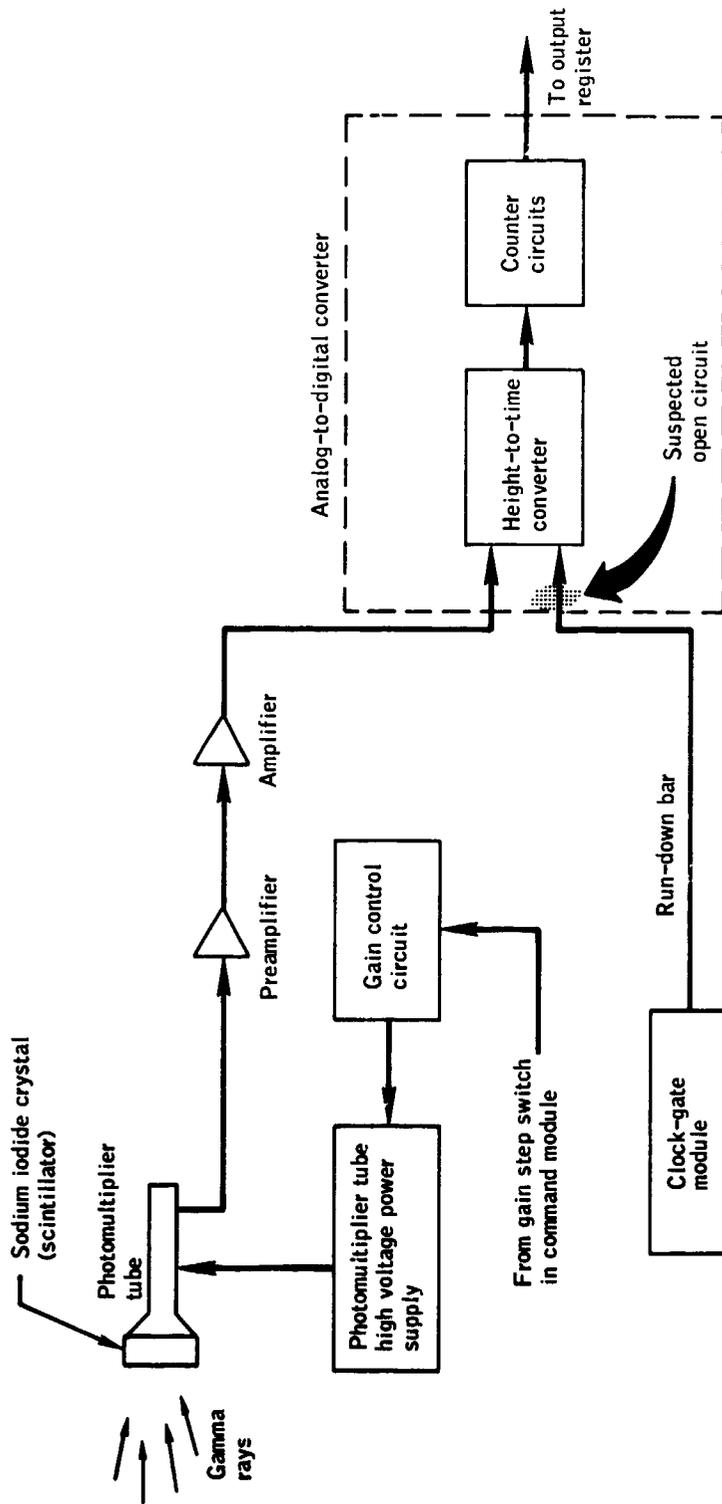
Figure 4-6.- Gamma ray spectrometer circuitry.

Evaluation to date indicates that the change in gain was possibly due to aging effects of the photomultiplier tube in the gamma ray detector assembly as a result of high cosmic ray flux rates in lunar operation. The zero shift appears to be associated with the run-down bar signal between the clock-gate module and the analog-to-digital converter (fig. 4-6). Absence of this signal at a particular point in the analog-to-digital converter removes a 3 microsecond offset in the pulse height analyzer. The resulting effect is an overall six-channel offset in the spectrum.

The qualification unit will be used to verify the gain change phenomenon at flux rates representative of those encountered in lunar operation. Subsequent to this, the qualification unit will be partially disassembled and tests will be performed to verify the nature of the zero-offset shift and identify the probable cause of the malfunction.

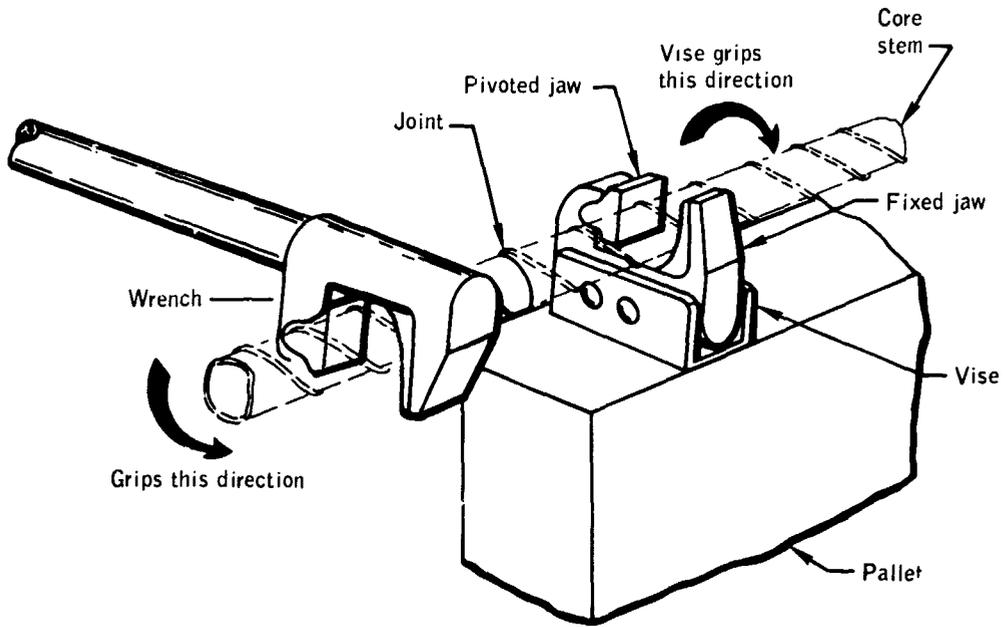
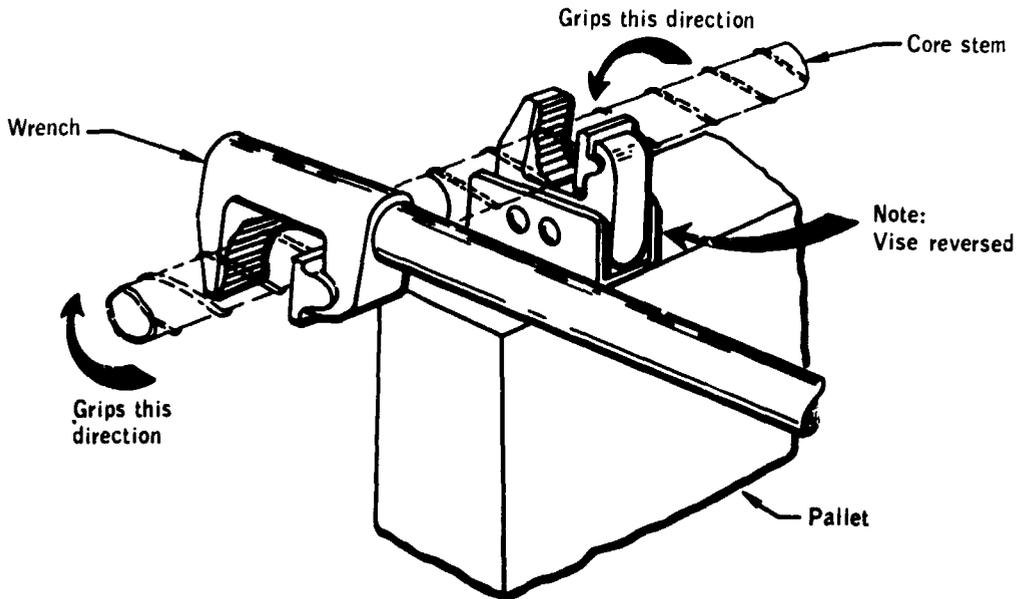
Figure 5-2.- Installation of core stem vise on rover pallet.

The wrench could be rotated to tighten, but not in the opposite direction to loosen and separate (fig. 5-2). There is insufficient clearance on the inboard side of the vise for wrench rotation, and the distance to the other side of the lunar roving vehicle is greater than the length of a core stem section.

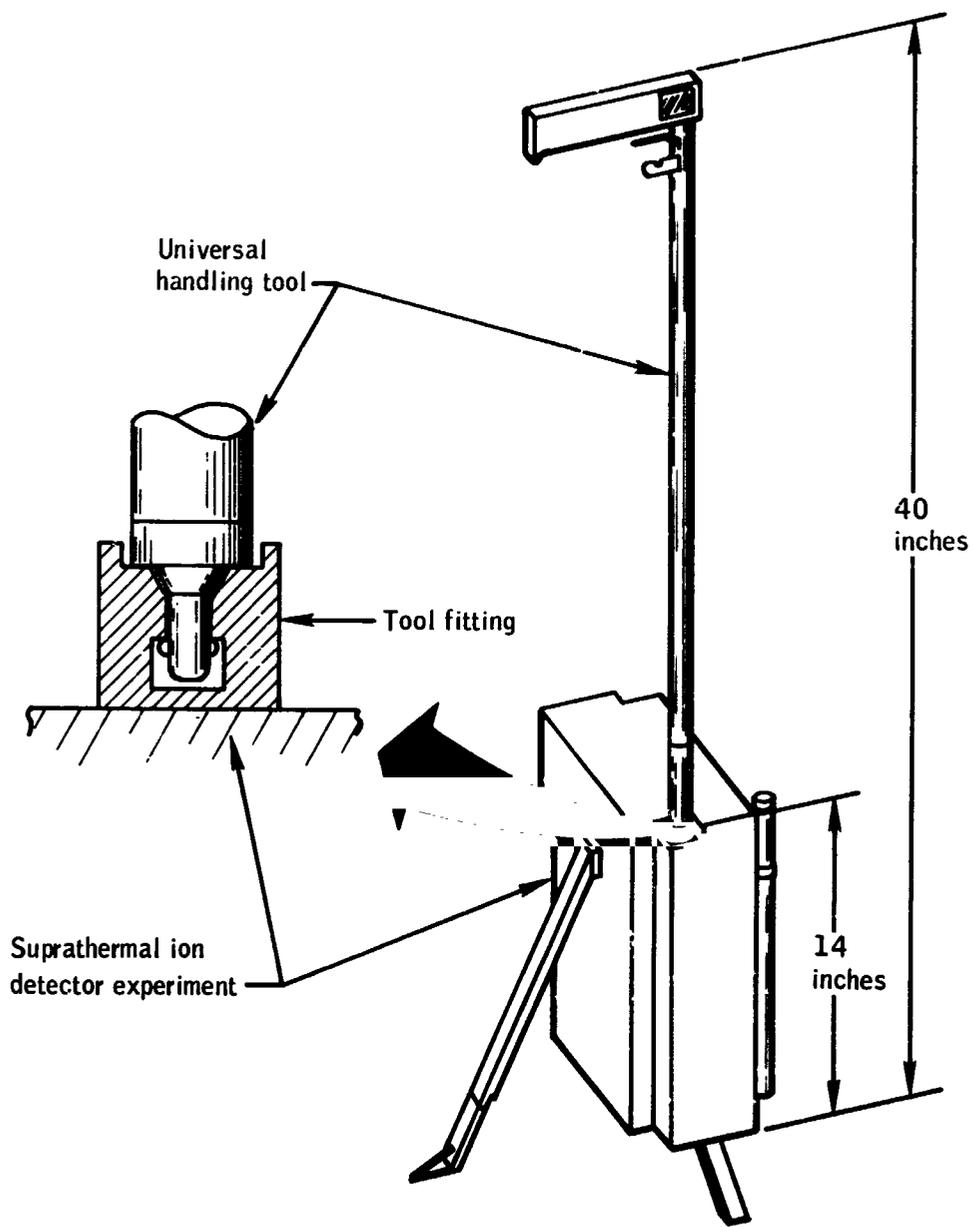
Figure 5-4.- Universal handling tool - suprathreshold ion detector experiment interface.

While carrying the suprathemal ion detector experiment from the subpallet to the emplacement site, the experiment fell off the universal handling tool at least twice. The experiment experienced no visible damage and has been operating satisfactorily.

Corrective action under consideration includes procedures to avoid inadvertant tool release triggering because of the positioning of the tool. The suprathemal ion detector experiment is not presently planned for any future missions.

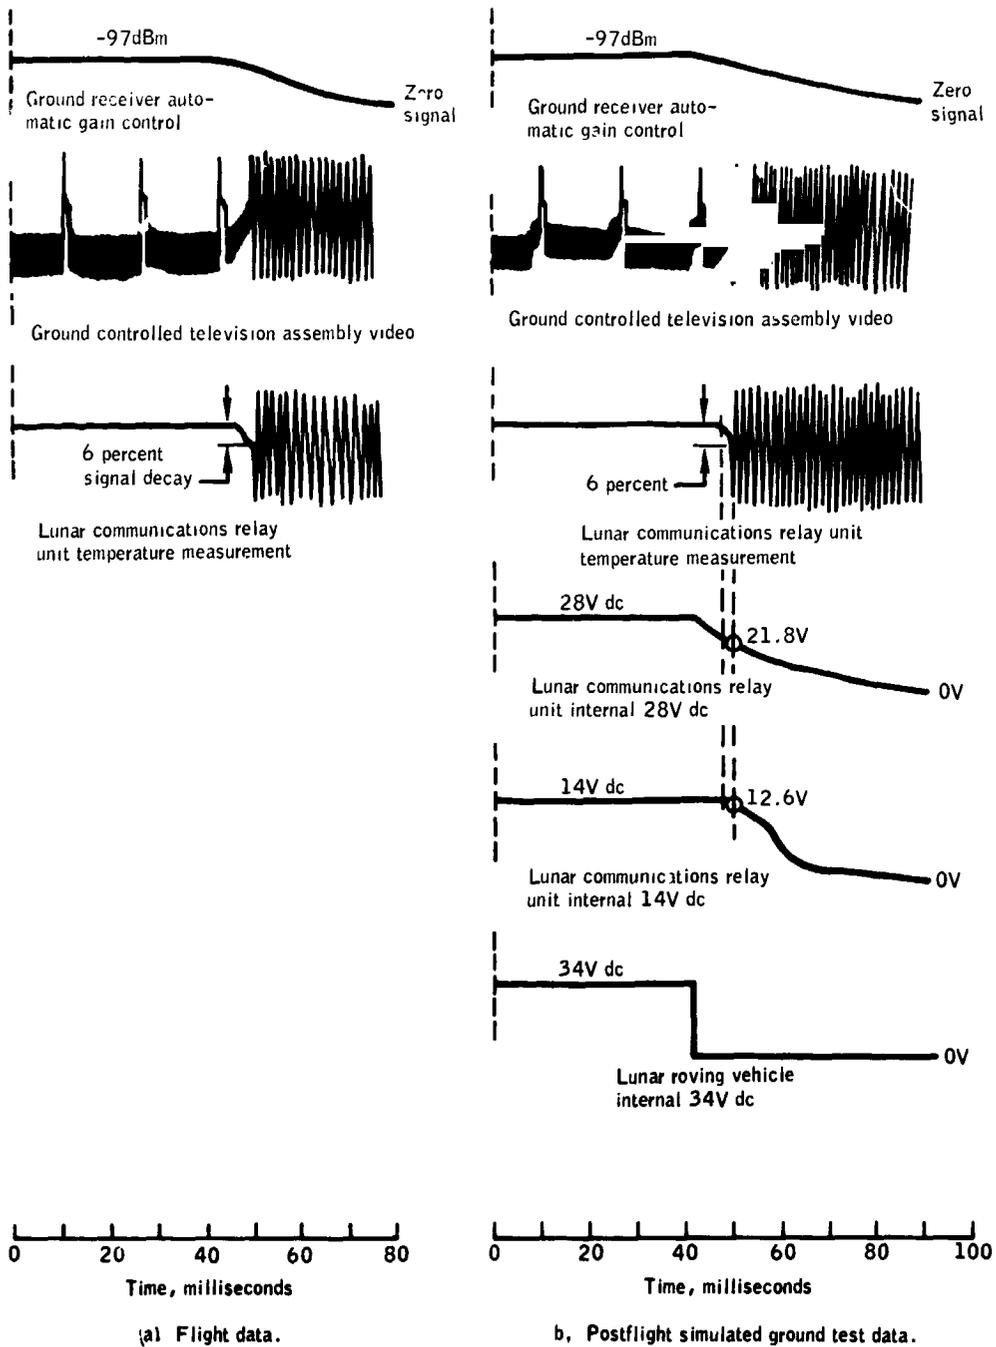
Figure 6-2.- Loss of power to lunar communications relay unit.

The lunar communications relay unit downlink signal was lost at 211:30:08, about 40 hours after lunar module ascent. The lunar communications relay unit operates on internal battery power during the extravehicular traverse but, just prior to the end of the third extravehicular

activity, the unit was manually switched to external lunar roving vehicle power in preparation for viewing lunar module ascent and for continuing television observations until 6 days after ascent. The power distribution from the lunar roving vehicle to the television is shown in figure 6-2. The television and transmitter had been commanded on from the ground 13 minutes prior to RF downlink signal loss. The lunar communications relay unit status subcarrier had been commanded on 7 minutes prior to signal loss. The television camera was stationary and a 1-second incremental iris movement was occurring at this time.
